Southwest Portland Cement Co., Nielson Sandstone Quarry,

ACT/023/012 (Formerly DOE/023/025)

Page 2
Memorandum - ACT/023/012
Nielson Sandstone Quarry
May 27, 1987

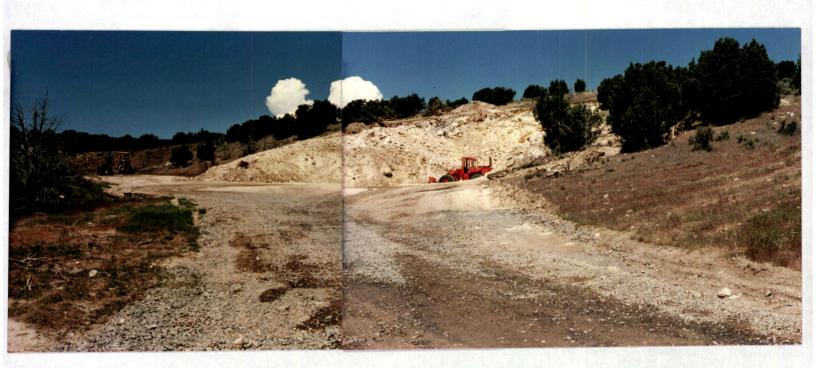
Photo #1 - Nielson Sandstone Quarry - May 21, 1987. This quarry #s southfacing and will be somewhat hard to revegetate unless a good layer (1-2 feet) of topsoil is put on the disturbed areas. If that much topsoil is put on and they are seeded properly, it will be possible to reestablish the required eight percent ground cover.

Note: The red colored vegetation is cheatgrass. It was not counted in the transect.

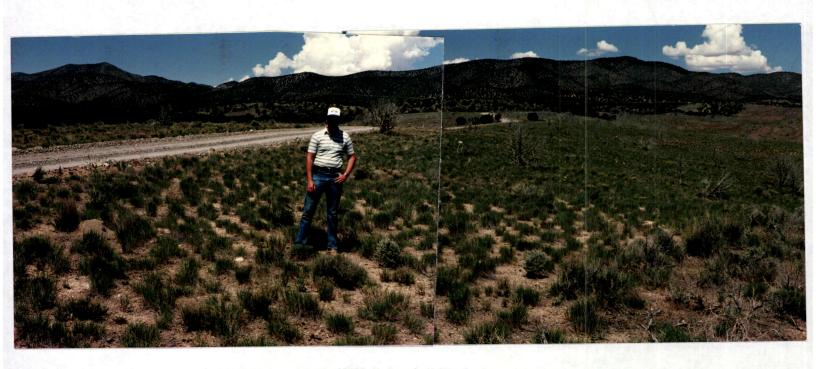
Photo #2 - This area, near the quarry, was reseeded by the Bureau of Land Management following a fire. It is a good seeding of crested wheatgrass and Russian wildrye. With this area so close, there is no need for a seeding study plot. (Terry Kerby in photograph).
